Western Regional Boiler Association

Specific Heat Exchanger/Condenser Applications

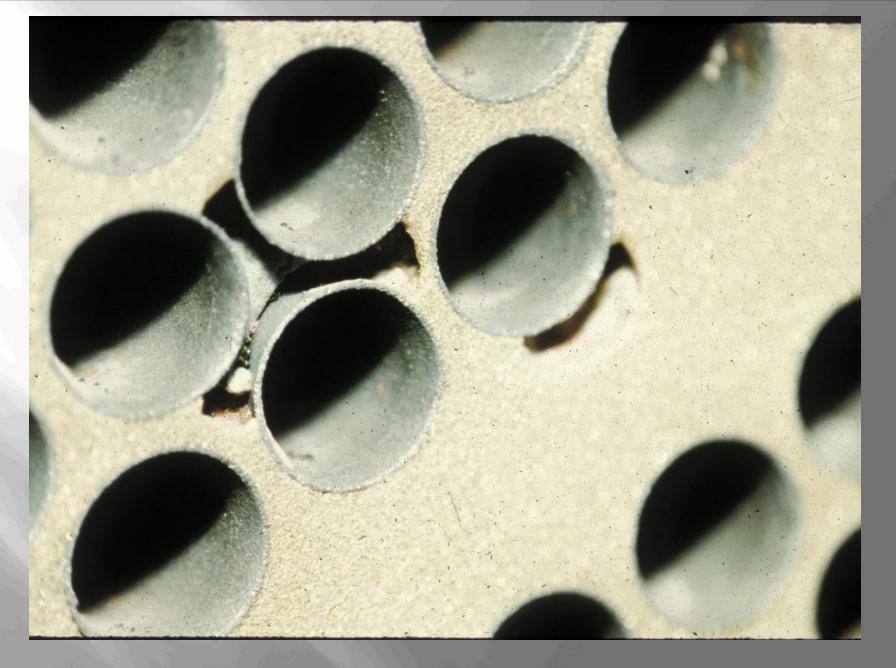
Aluminum bronze tubesheet with titanium tubes

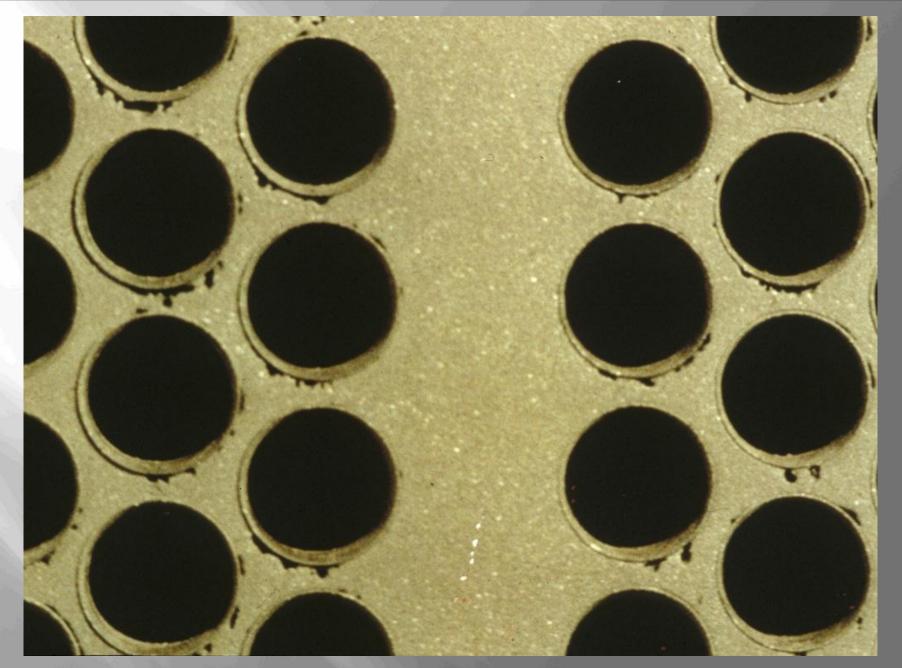
Crevice Corrosion and MIC on Stainless Steel

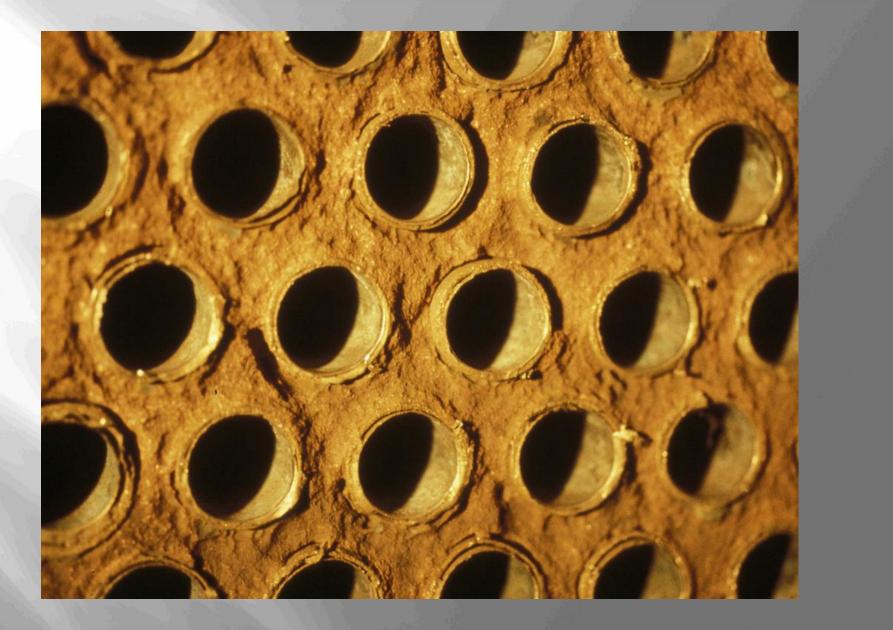
Galvanic attack and erosion of Muntz Metal Tubesheet

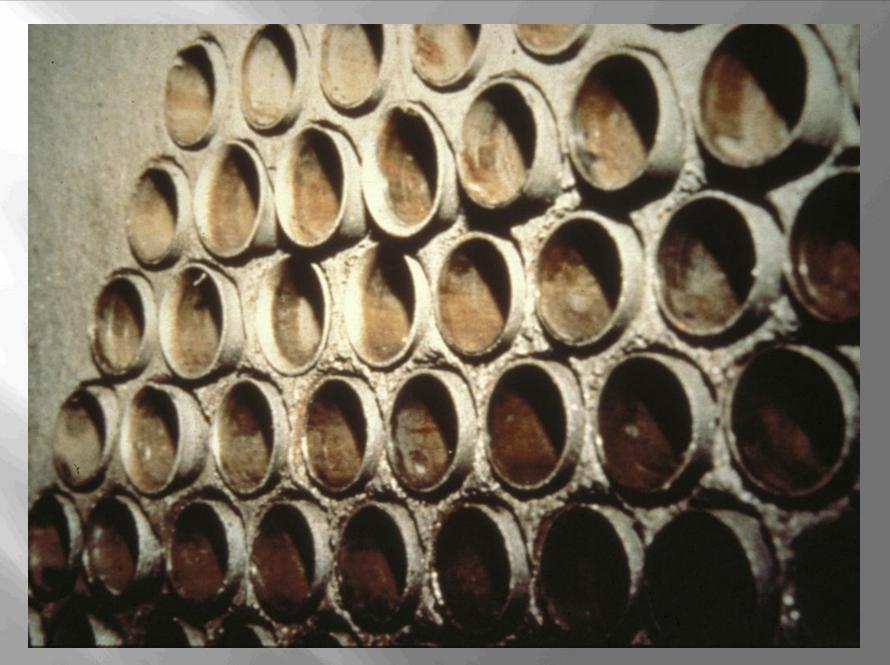
Galvanic Attack – Stainless Tubes with Carbon Steel Tubesheet

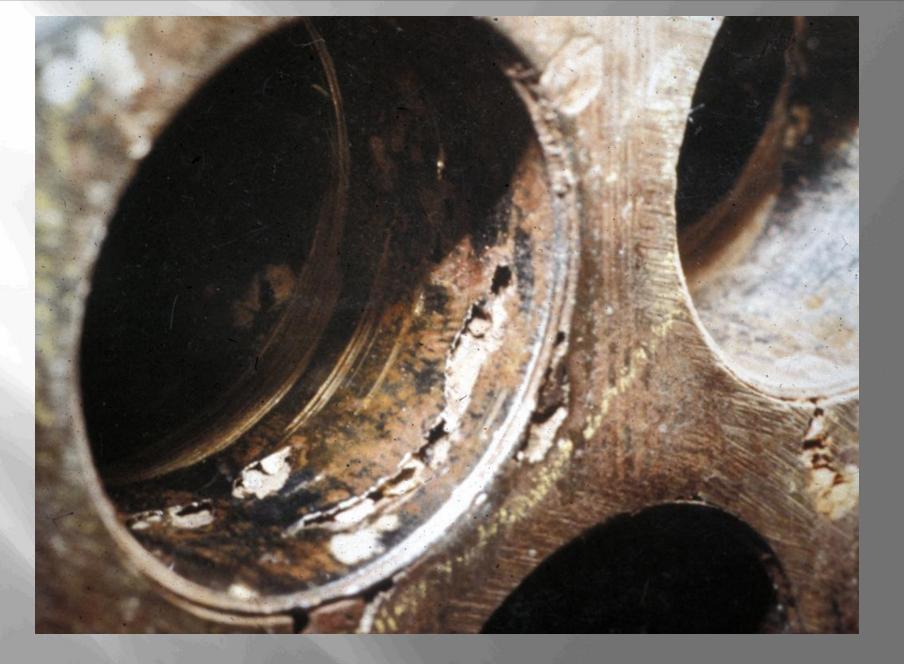
Crevice Corrosion and MIC on Stainless Steel

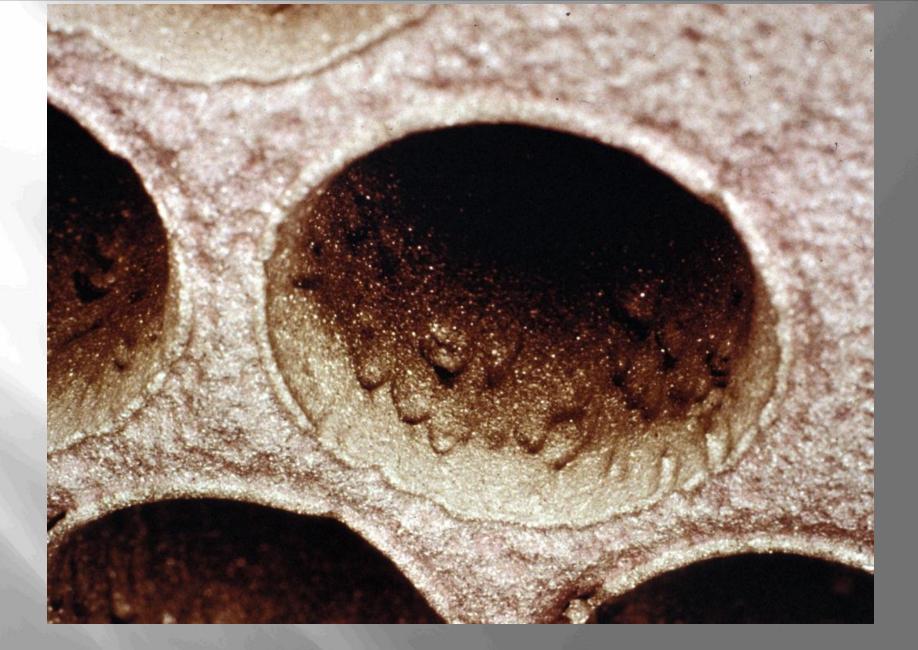
Inlet tube erosion on copper alloy tubes

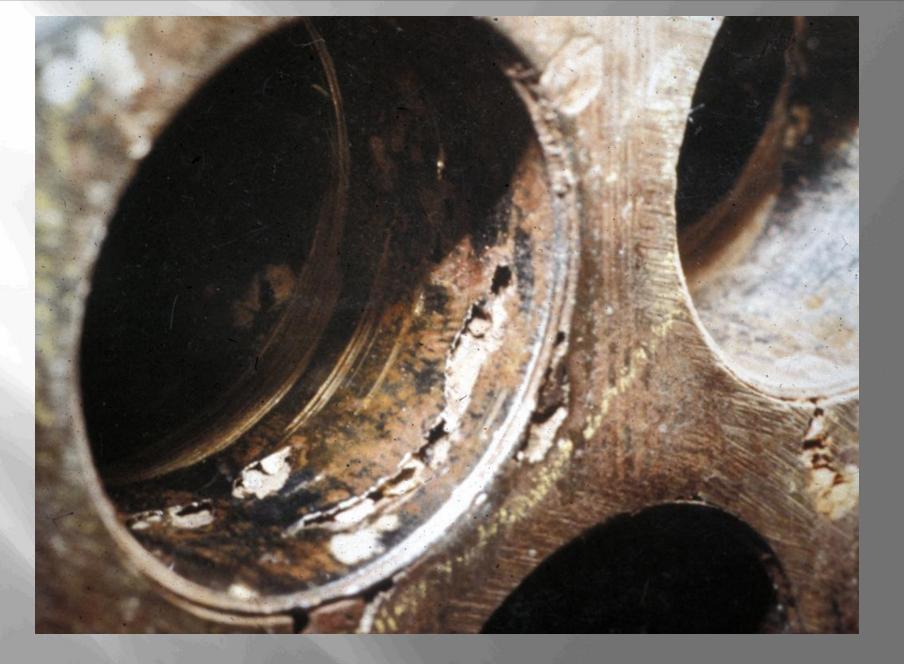
Crevice Corrosion and MIC on Stainless Steel

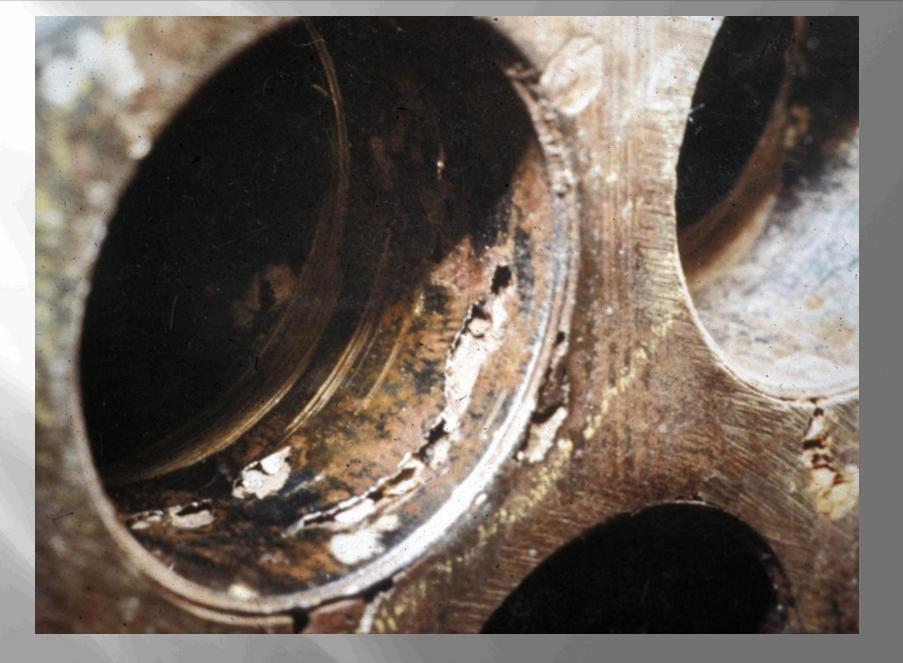
Microbiological Corrosion (MIC) on Stainless

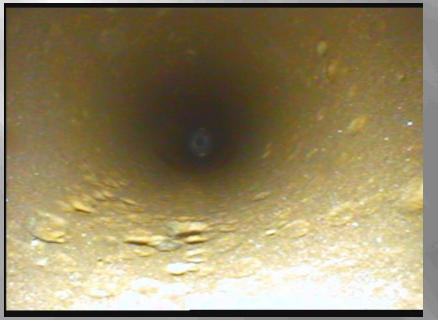
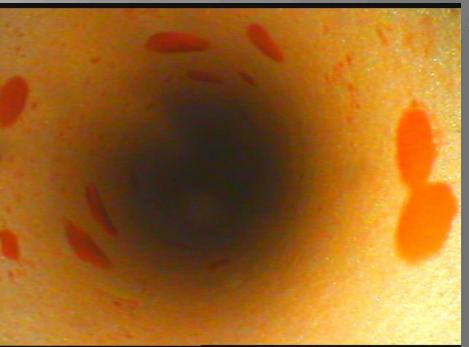
Hydrogen Cooler holes and pits

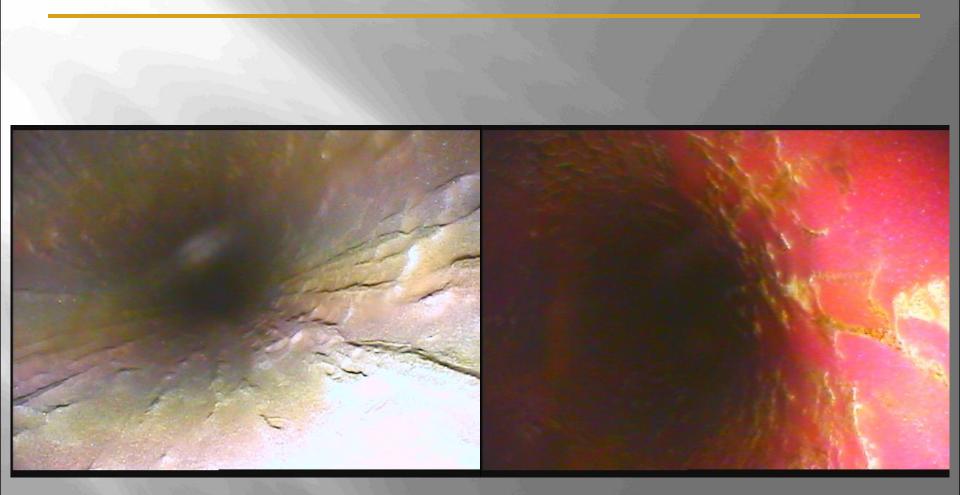
Case 3 - Do or Die epoxy "dots" on tube OD showing repaired holes
