Improving Boiler Reliability Through NDT

TesTex Inc.

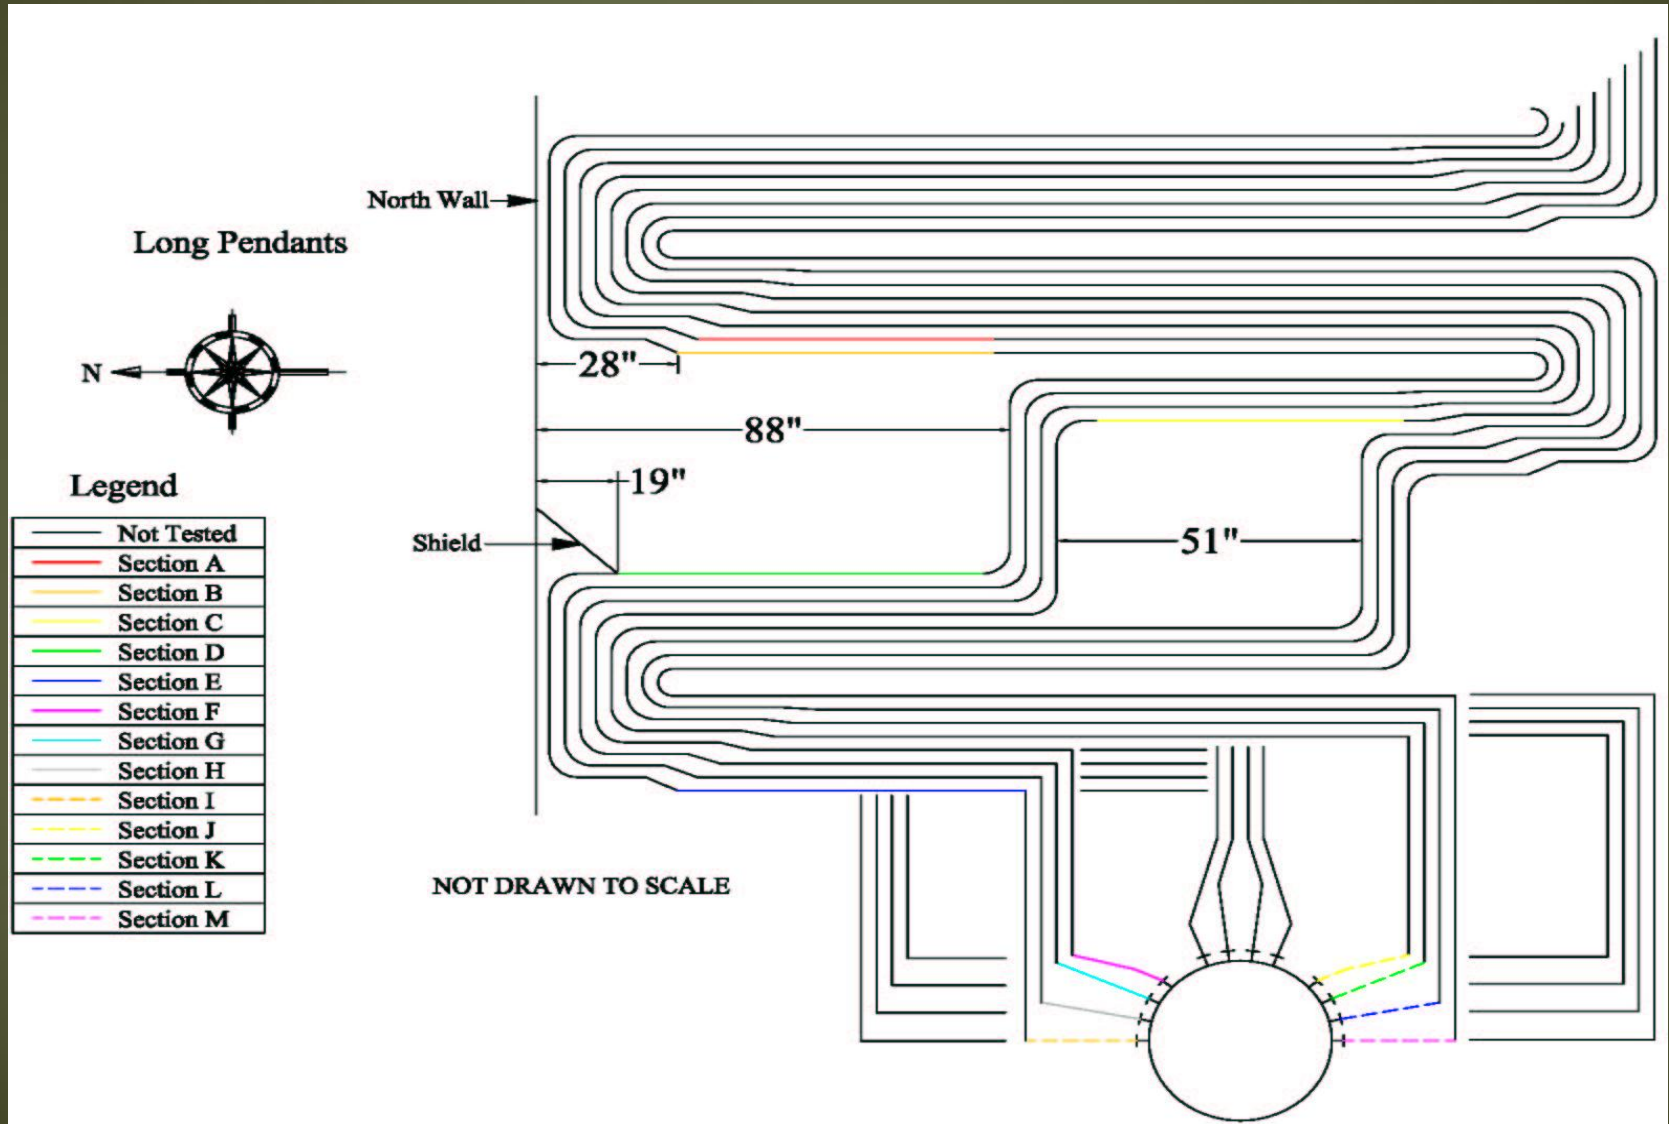
Case Study 1

Problem: Tube failures in the Horizontal Reheater due to oxidation pitting.
Access between tubes is .75". Pendants are spaced tightly together.

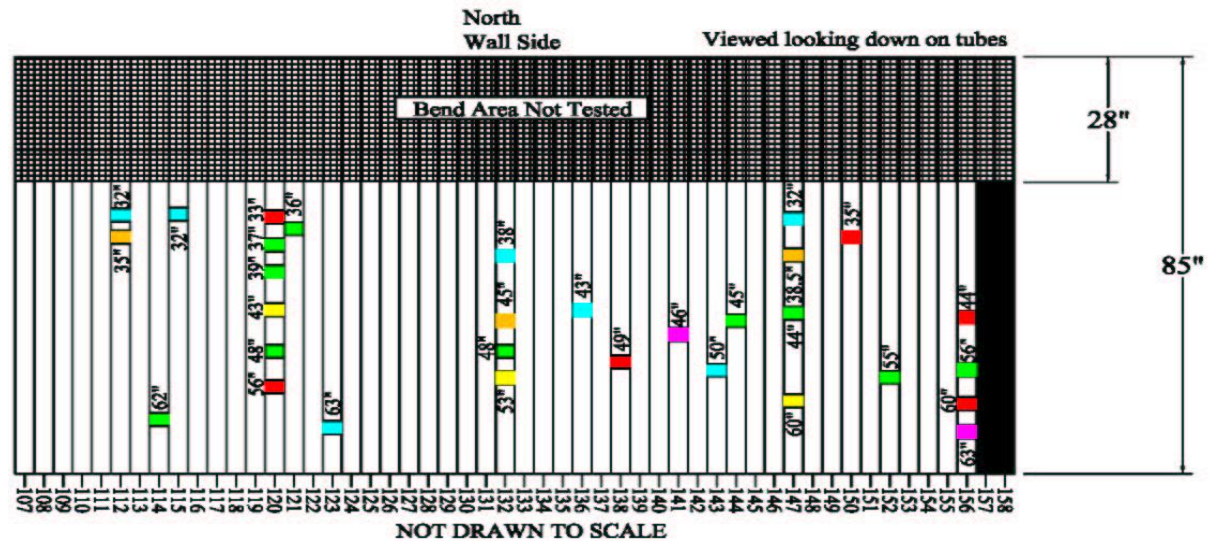
Case Study 1

Western PA Boiler

#3 Boiler

5 Areas Inspected

44 tubes with defects found

Major flaws found were cut-out and replaced with Dutchmans.

Minor defects were pad welded.

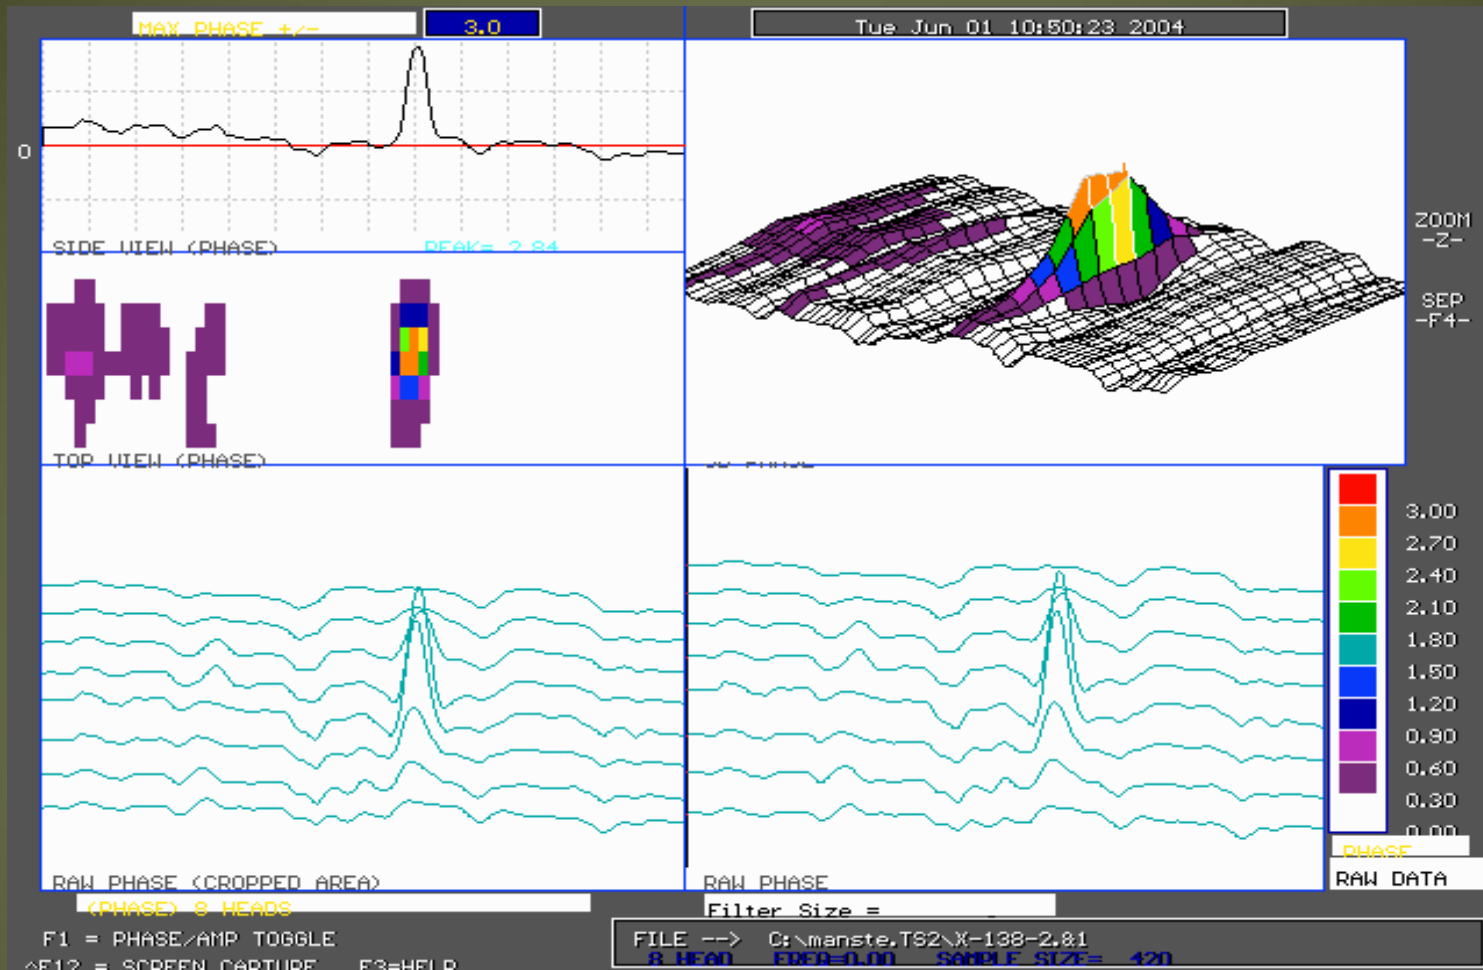
Case Study 1

Due to the amount of indications found in unit 3's reheater section, it was determined to also scan units 1 and 2's reheater section

All 3 units' reheater sections were replaced during the next scheduled outage

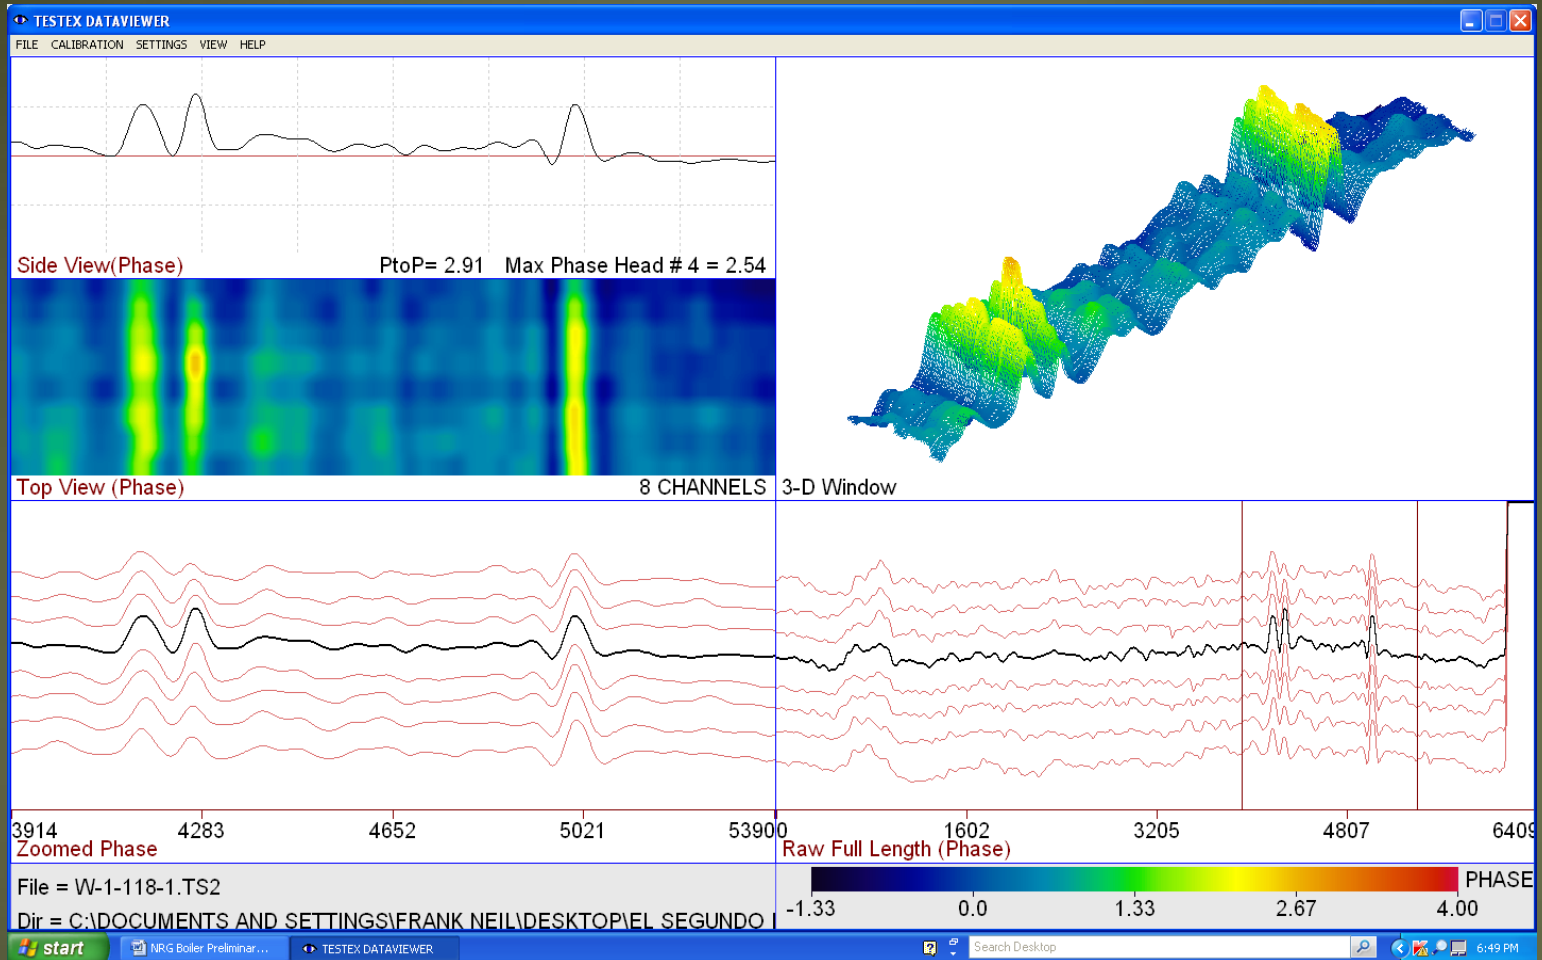
Case Study 2

A power plant in southern California was experiencing roof tubes rupturing in their Unit 3 boiler due to hydrogen damage.

14 tubes were found to contain hydrogen damage

All tubes with indications were cut out and verified immediately
After detection.
